Manhole Inspection Summary

Manhole # S03CC2015MH

Location Address: **6210 CROSS COUNTRY BLVD** Cross Street: **VERDENE AVE**

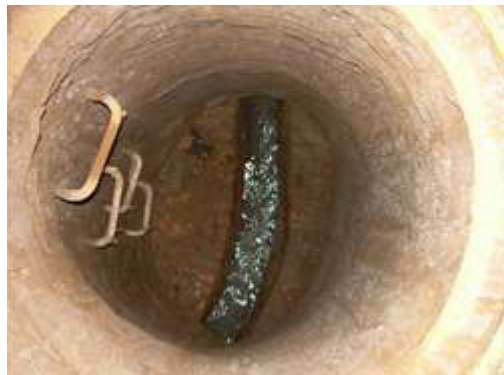
Top View

Frame Offset: **0** (in.) Condition: ☐ Sound ☐ Cracked ☒ **Leaks**

Bench ☒ Exists Material: **Brick** ☐ Parged ☒ **Debris** (not Condition related)
Condition: ☒ Sound ☐ Cracked ☐ Root Intrusion ☐ Deteriorated ☐ Leaks ☐ Debris

Steps Count: **4** Missing: **0** ☒ **Corroded**

Frame leaks. Corroded steps. Bench debris.

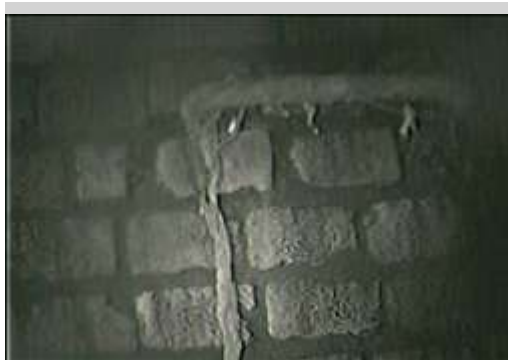
Evidence of surcharge

Surcharge ☒ **Evidence Of Surcharge** Depth: **4** (ft.) ☐ Active Surcharge Present

Evidence of surcharge.

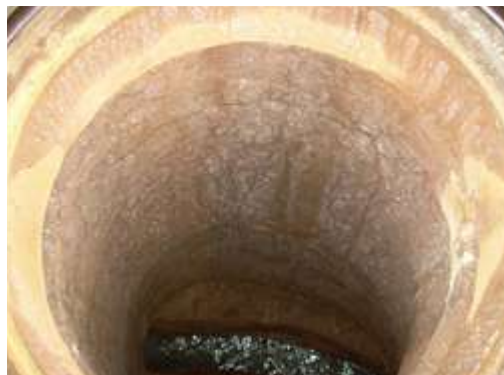
Defect

Chimney / Frame Adjustment ☒ Exists Material: **Brick** ☐ Parged Height: **3** (in.)
Condition: ☒ Sound ☐ Cracked ☐ Root Intrusion ☐ Loose Brick ☐ Deteriorated
Infiltration: ☐ None ☒ **Joint** ☐ Cracks ☐ Mortar ☐ Roots ☐ Wall

INFILTRATION ADJUSTMENT

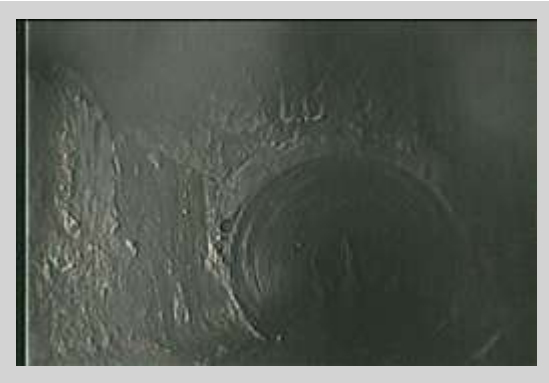
10 in. Circular Gravity Sewer Pipe Out @ 12 O'Clock

Infiltration: **None** Pipe Seal Cond: **Unknown**

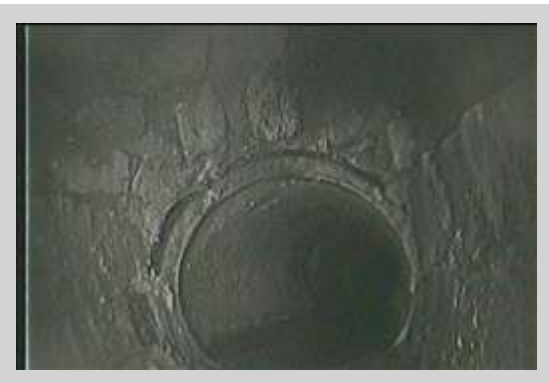
10 in. Circular Gravity Sewer Pipe In @ 7 O'Clock

Comments **The I7 pipe seal is not flush to the pipe**

Infiltration: **Evidence** Pipe Seal Cond: **Unknown**
